PBY Catalina

Walk Around Number 5
squadron/signal publications

By William Scarborough
Color by Don Greer
Illustrated by Joe Sewell

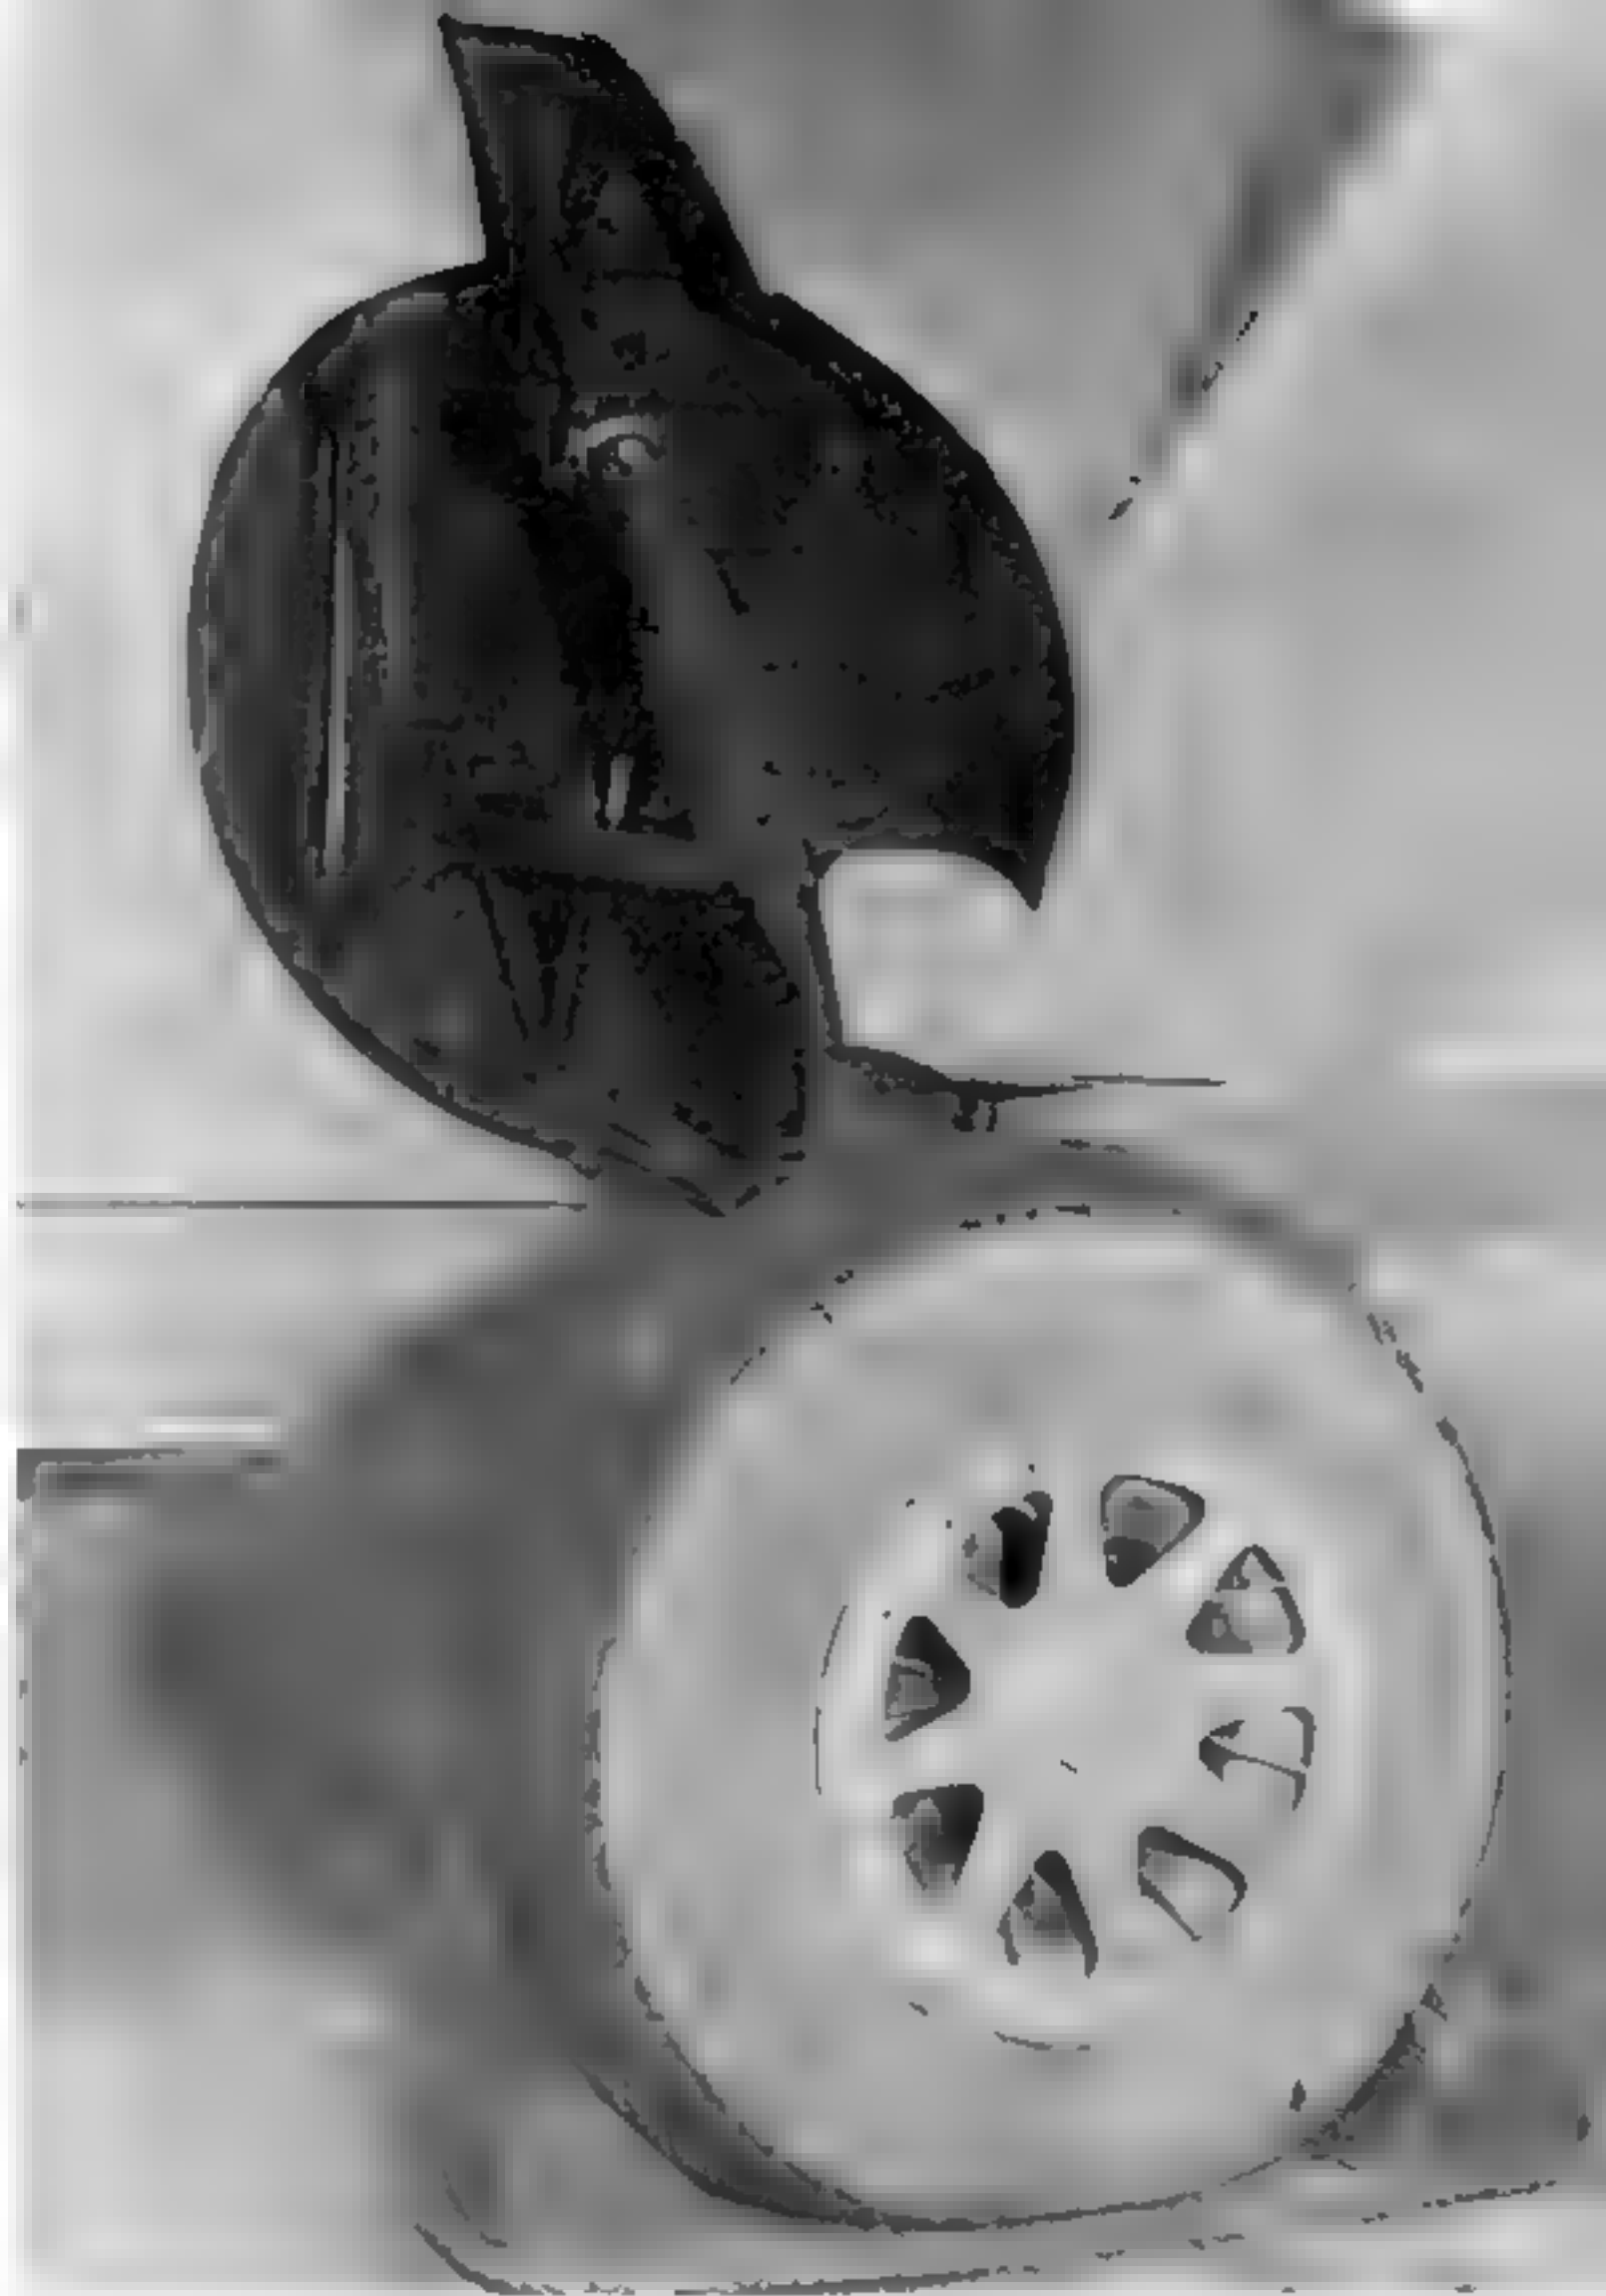
The PBV-5A main landing gear had the telescopic actuator strut (top) and smaller upper and lower vee support struts attached by bolts directly to the oleo strut, along with the small two piece landing gear well doors. (Tom Tullis)

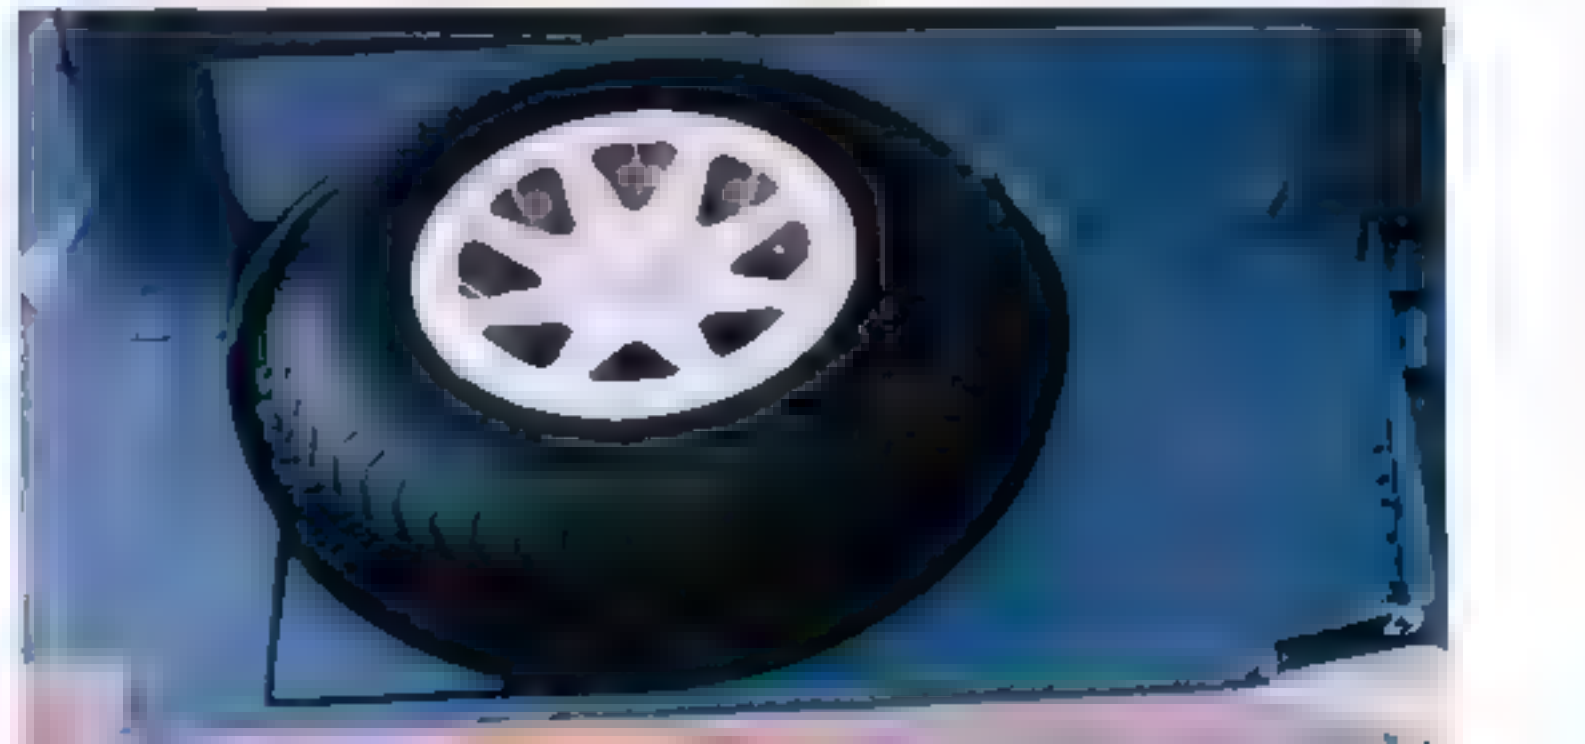
The main landing gear of a PBX-5A in the fully retracted position. The two struts to the right and left of the wheel are the lower portion of the wing support struts. All PBXs used a spoked wheel. (Richard Dann)

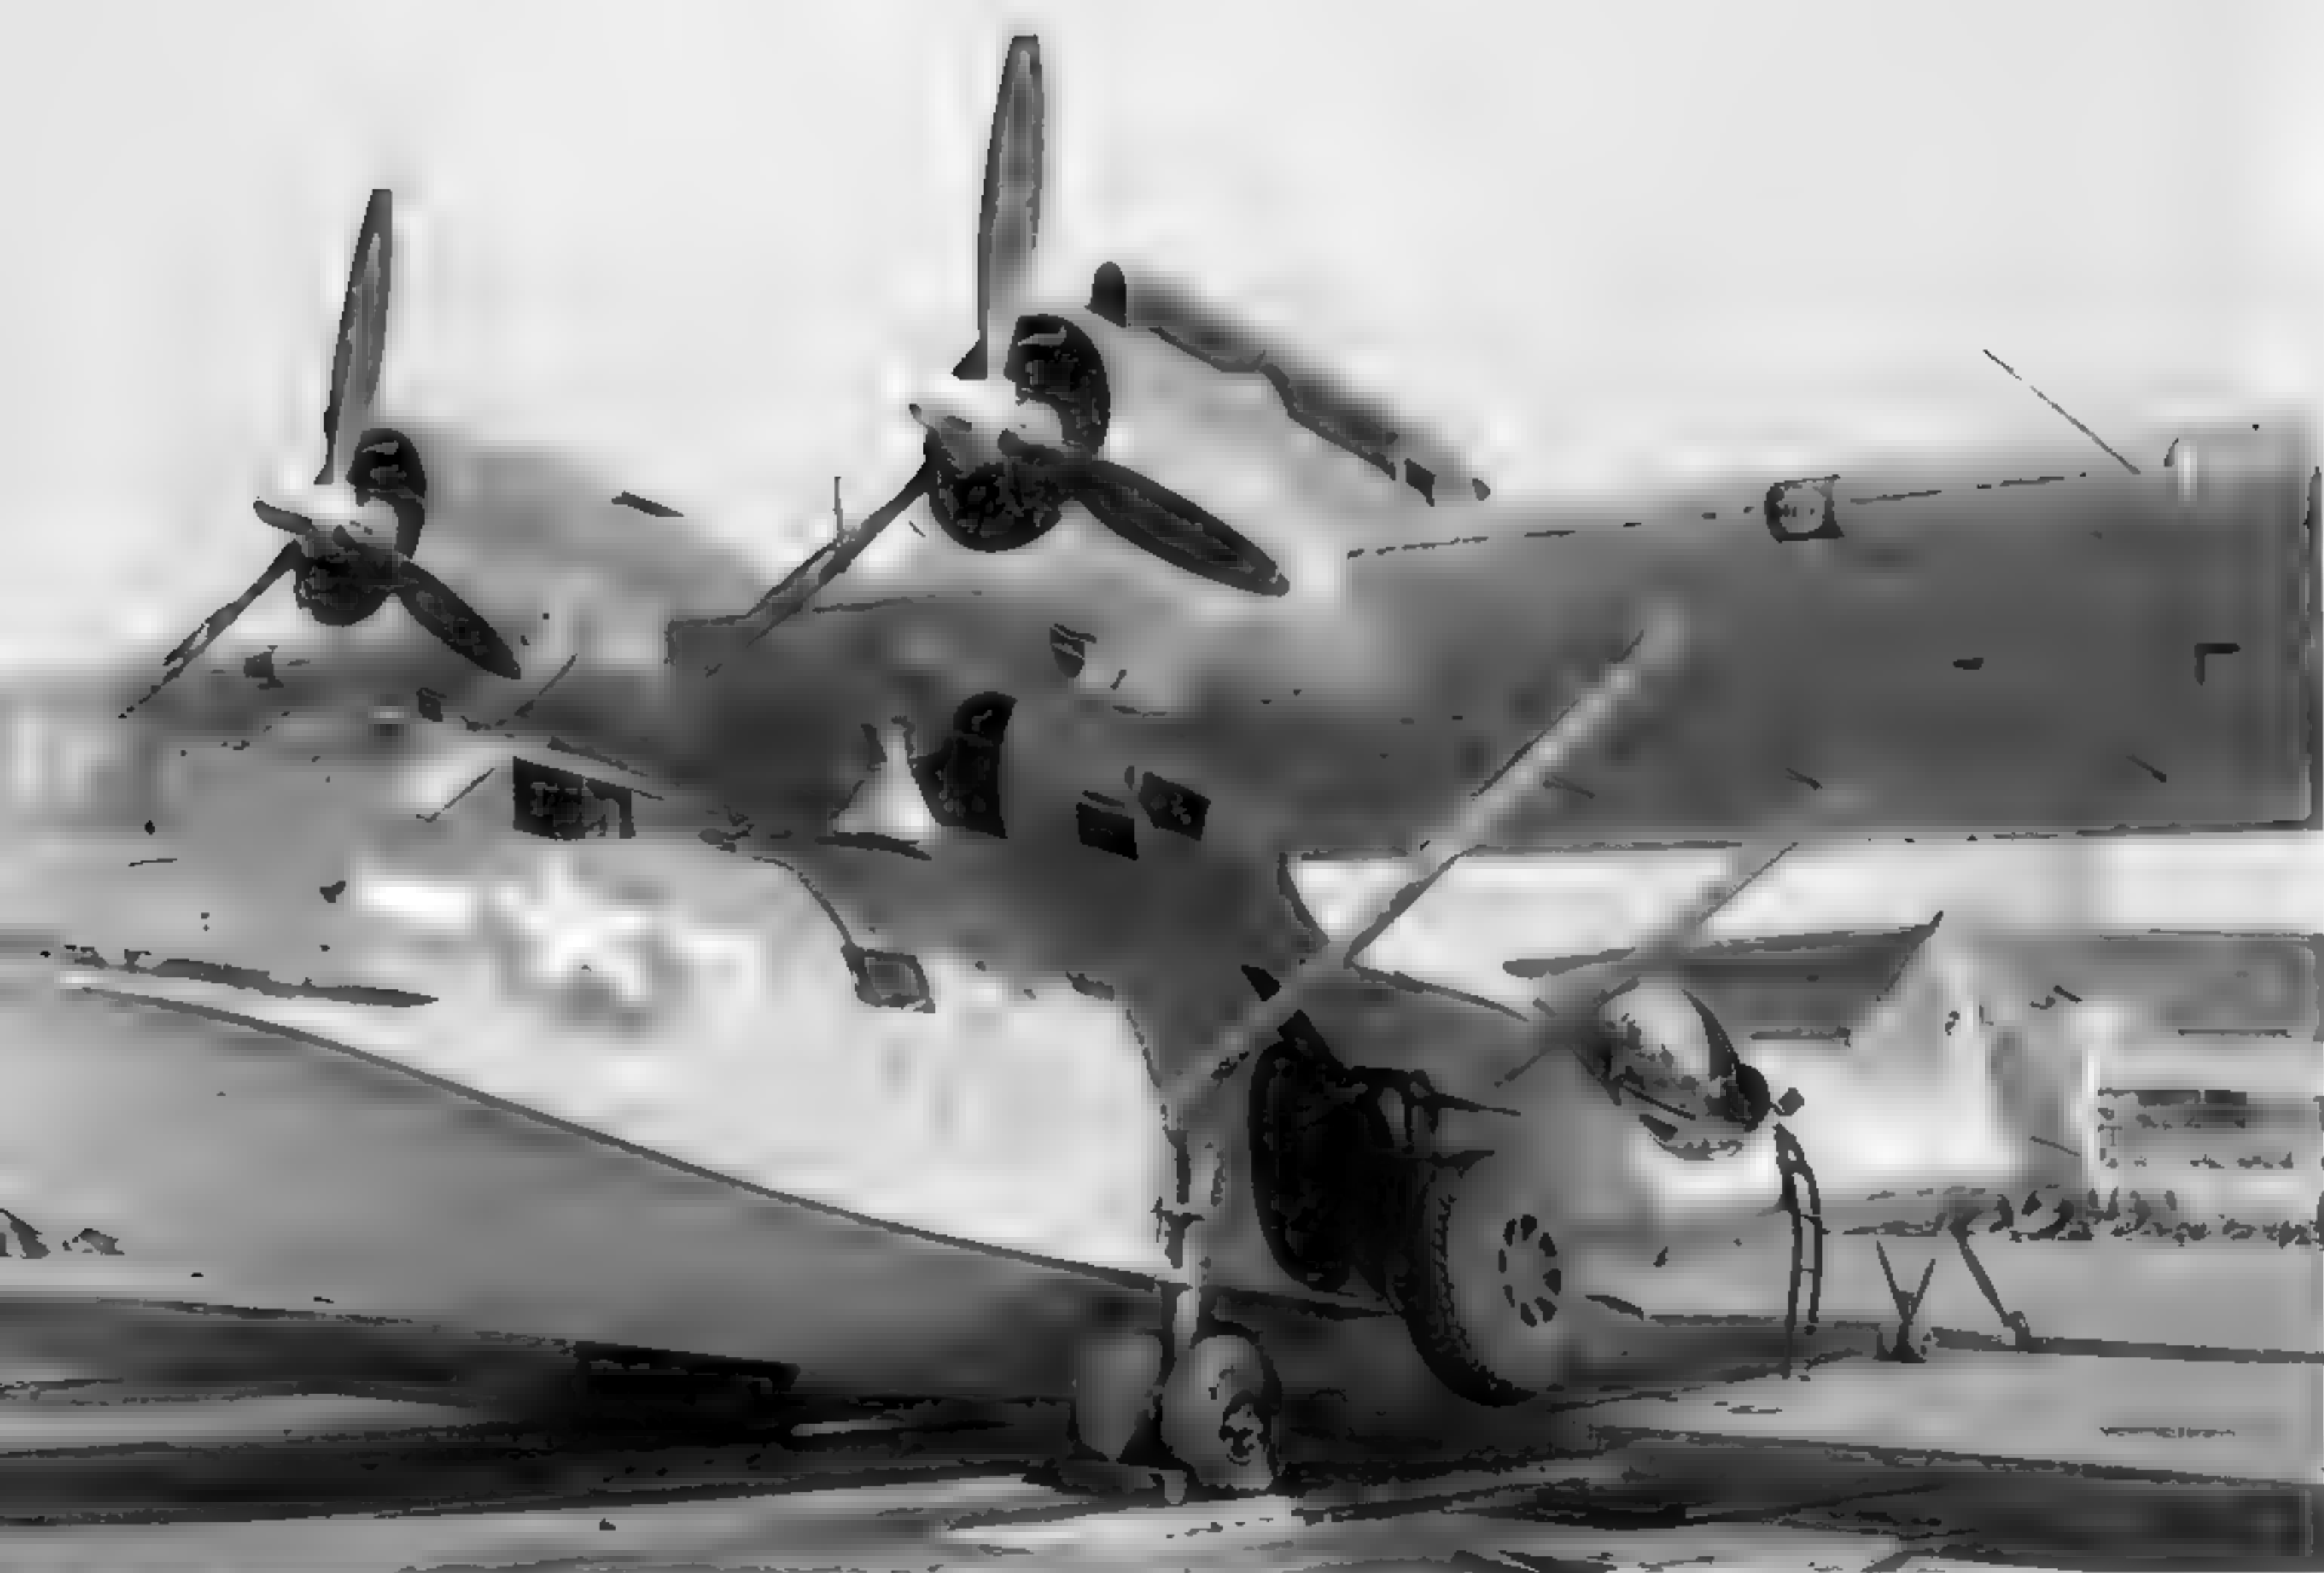
PBY-5A landing gear maintenance was frequently accomplished by installation of beaching gear and parking the aircraft adjacent to a pit, instead of using lifting jacks. The housing above the engine nacelle covered the heat exchanger for the wing thermal deicing system. The air intake for the gasoline-fueled tail thermal deicing system is visible on the lower leading edge of the fin. (CAC)

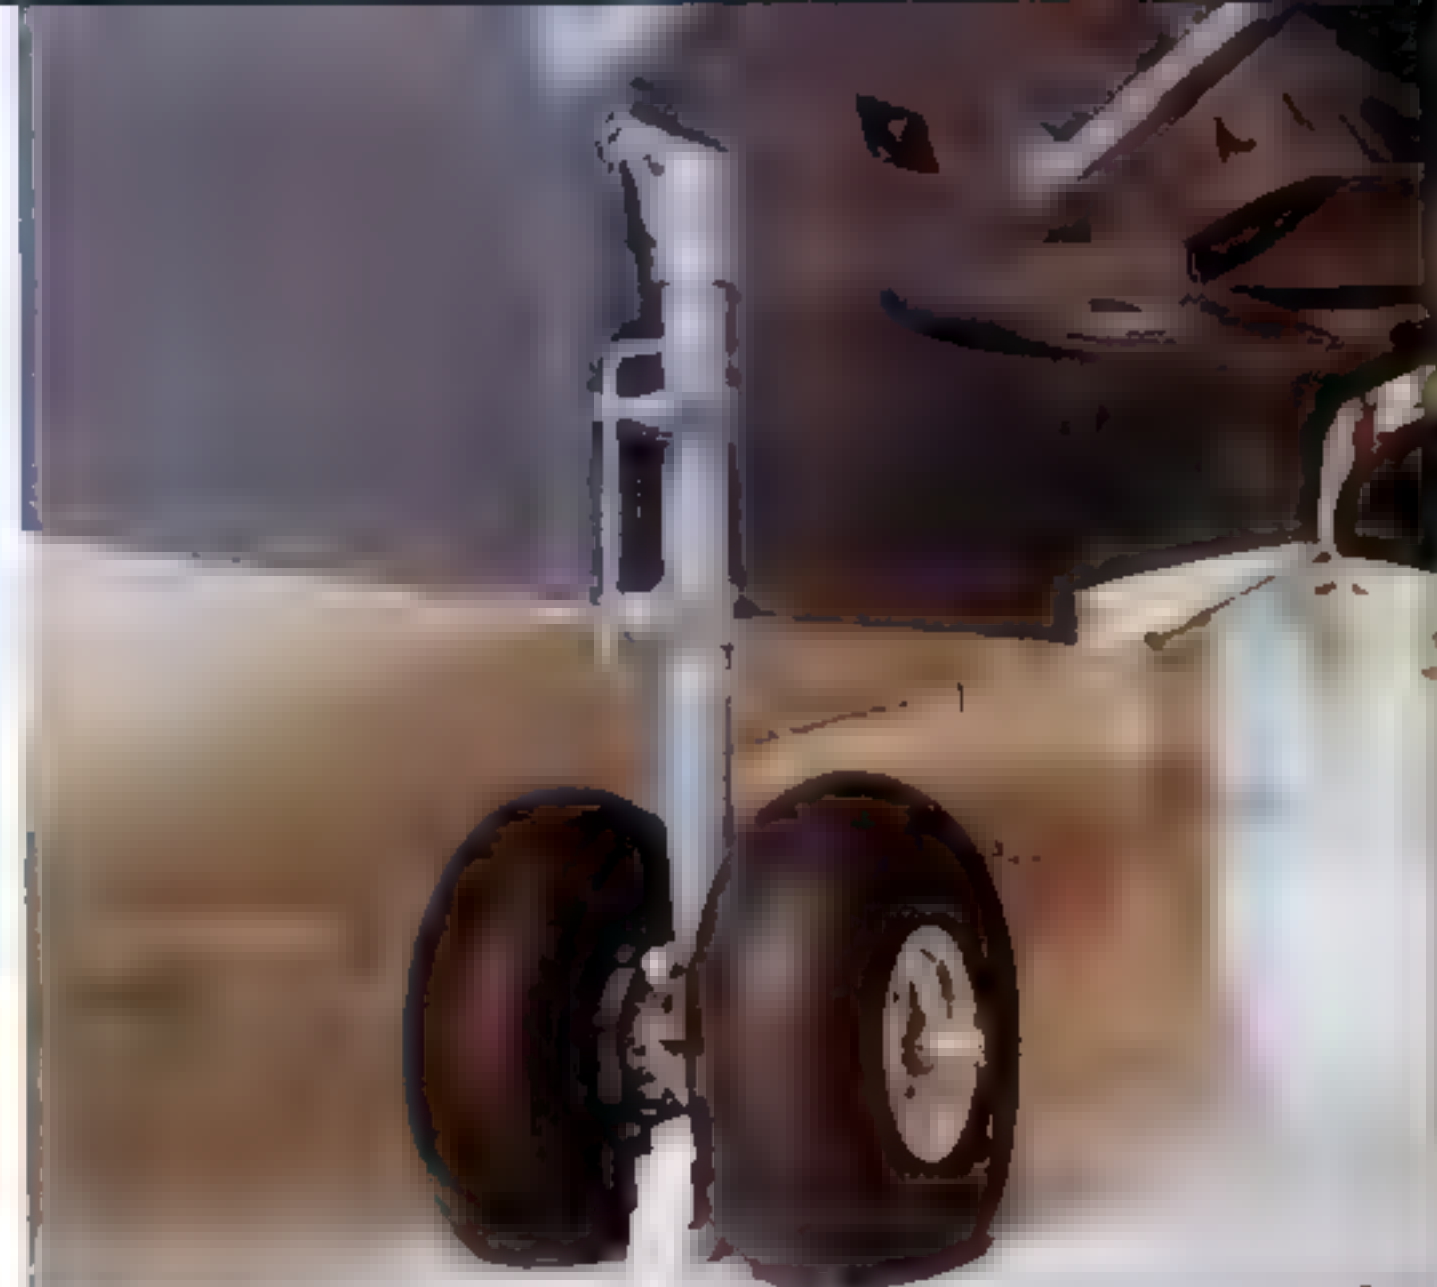
The starboard main beaching gear hull attachment sockets of the PBV-5 at the National Museum of Naval Aviation. (Ross Creed)

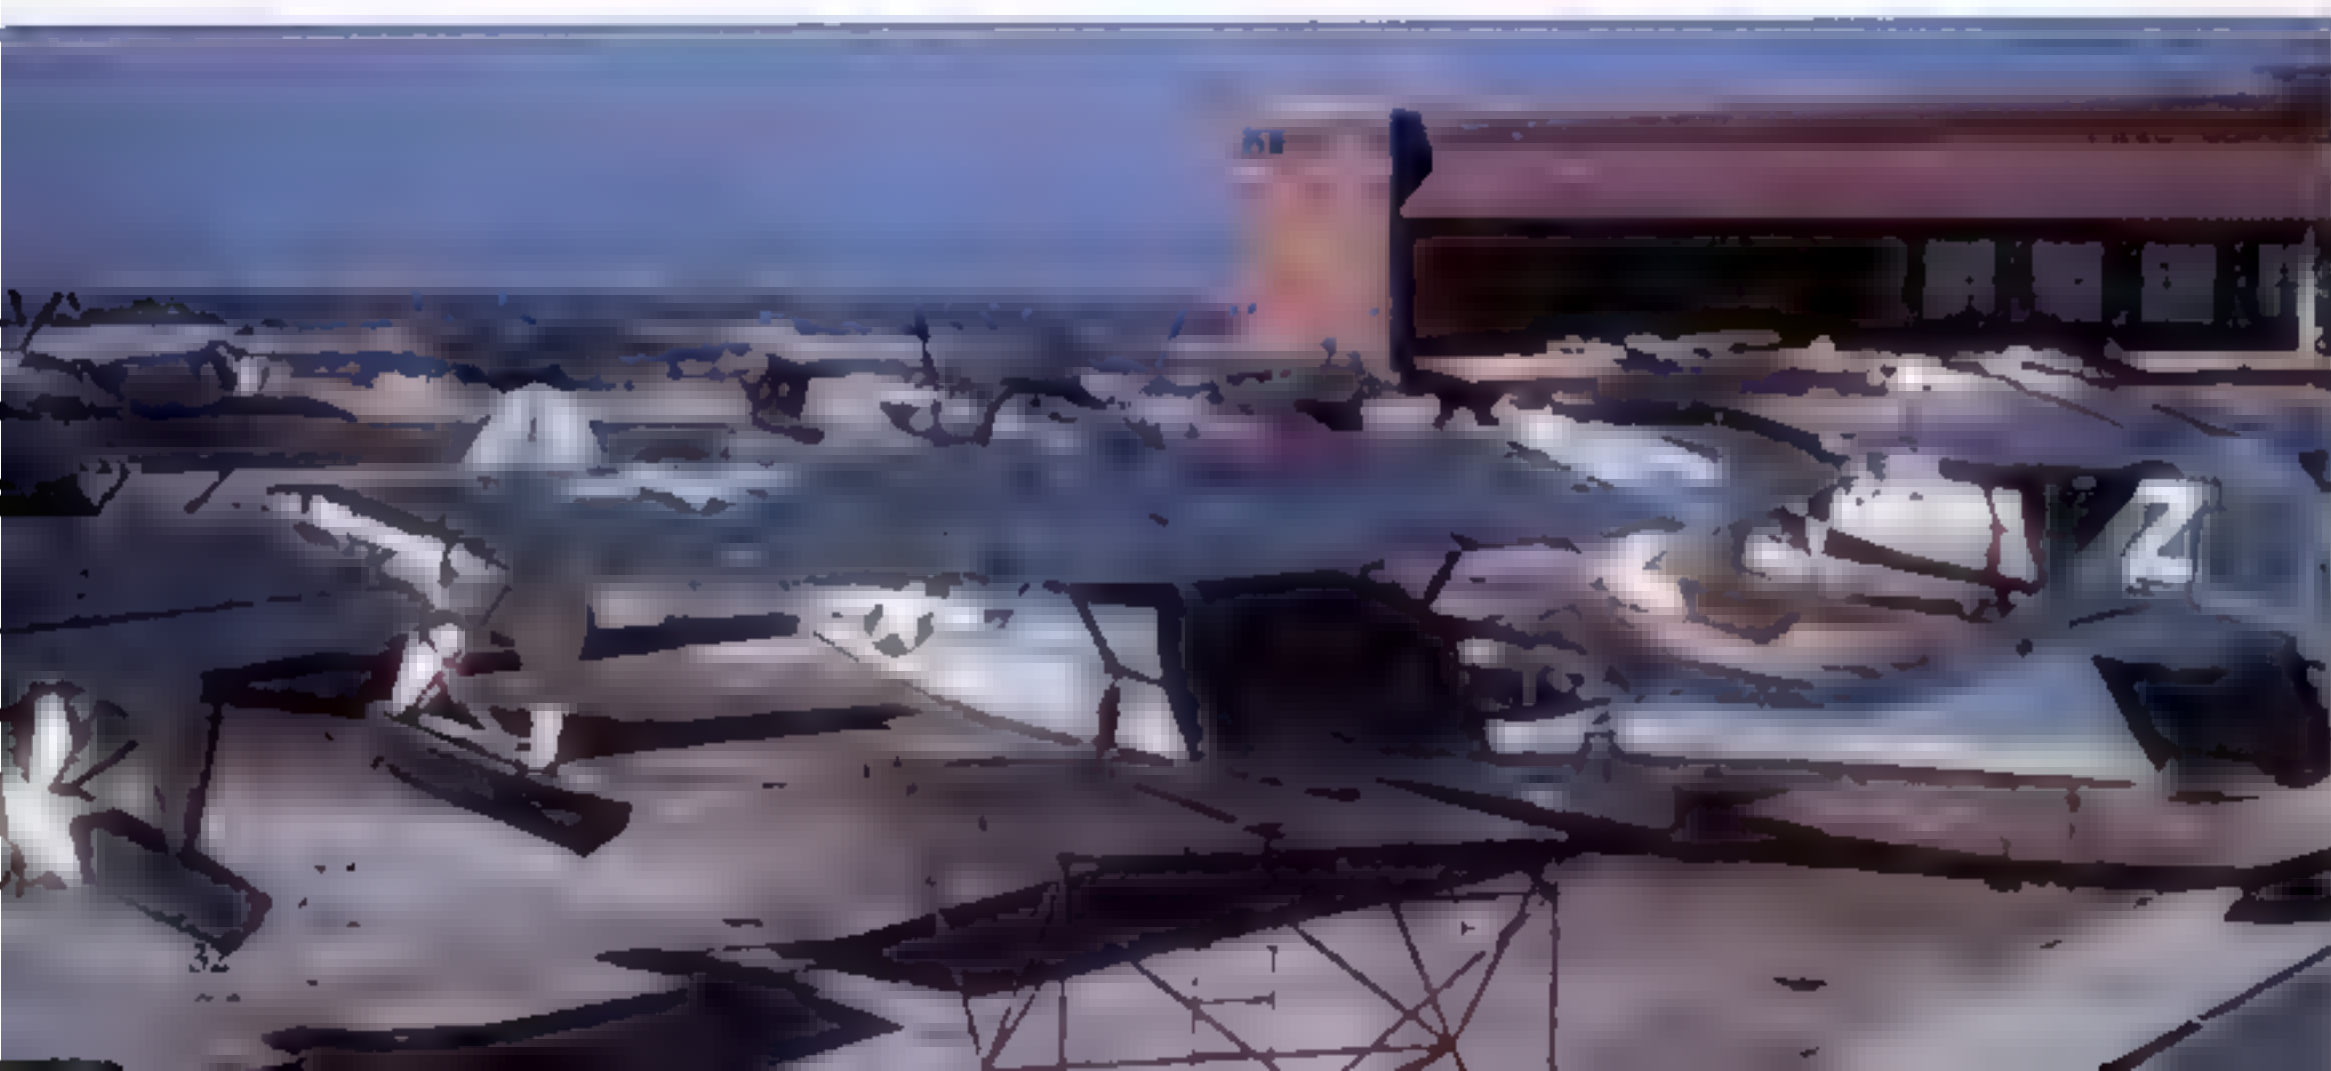
The port main beaching gear in place on the PBV-5 at the National Museum of Naval Aviation. The main beaching gear strut was temporary up on blocks. (WES)

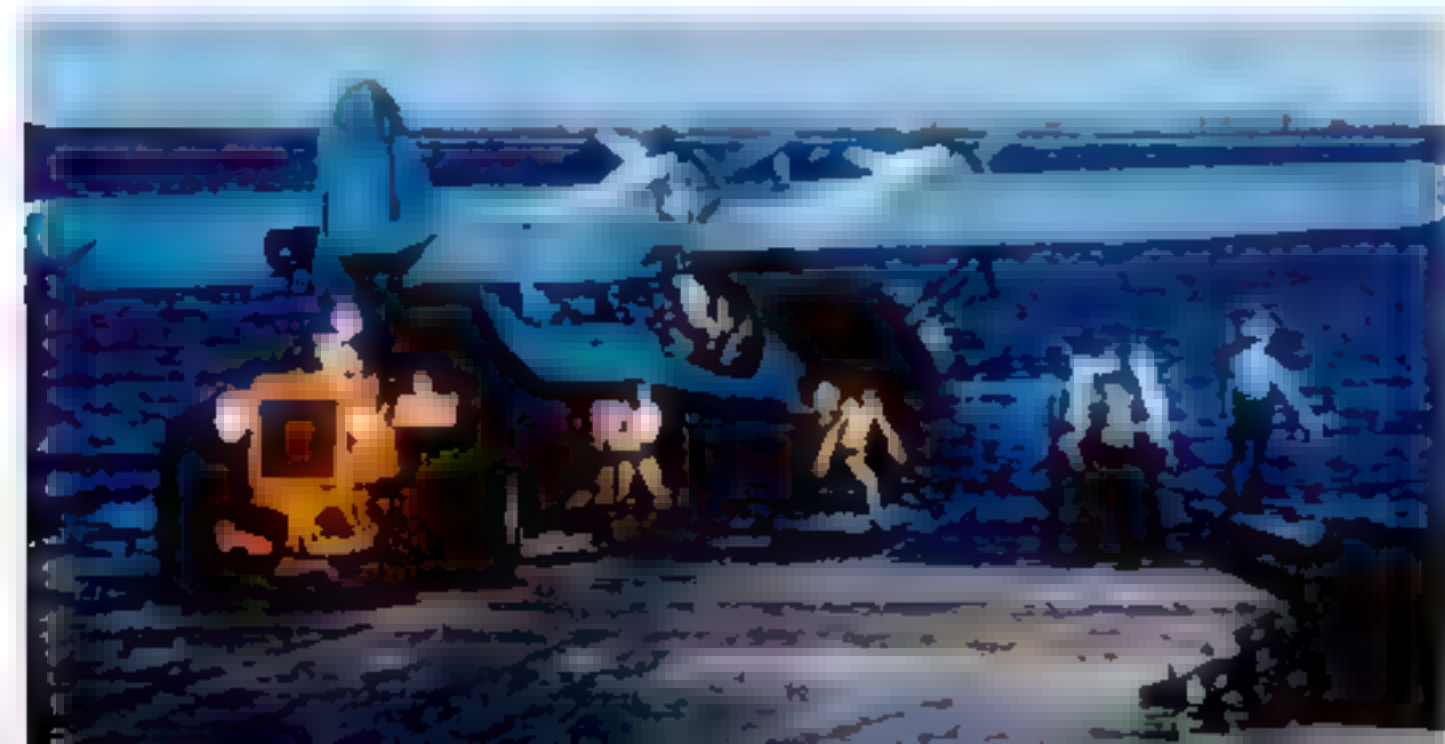
The two mounting sockets for tail beaching gear struts were located on the bottom of the rear hull. (WES)

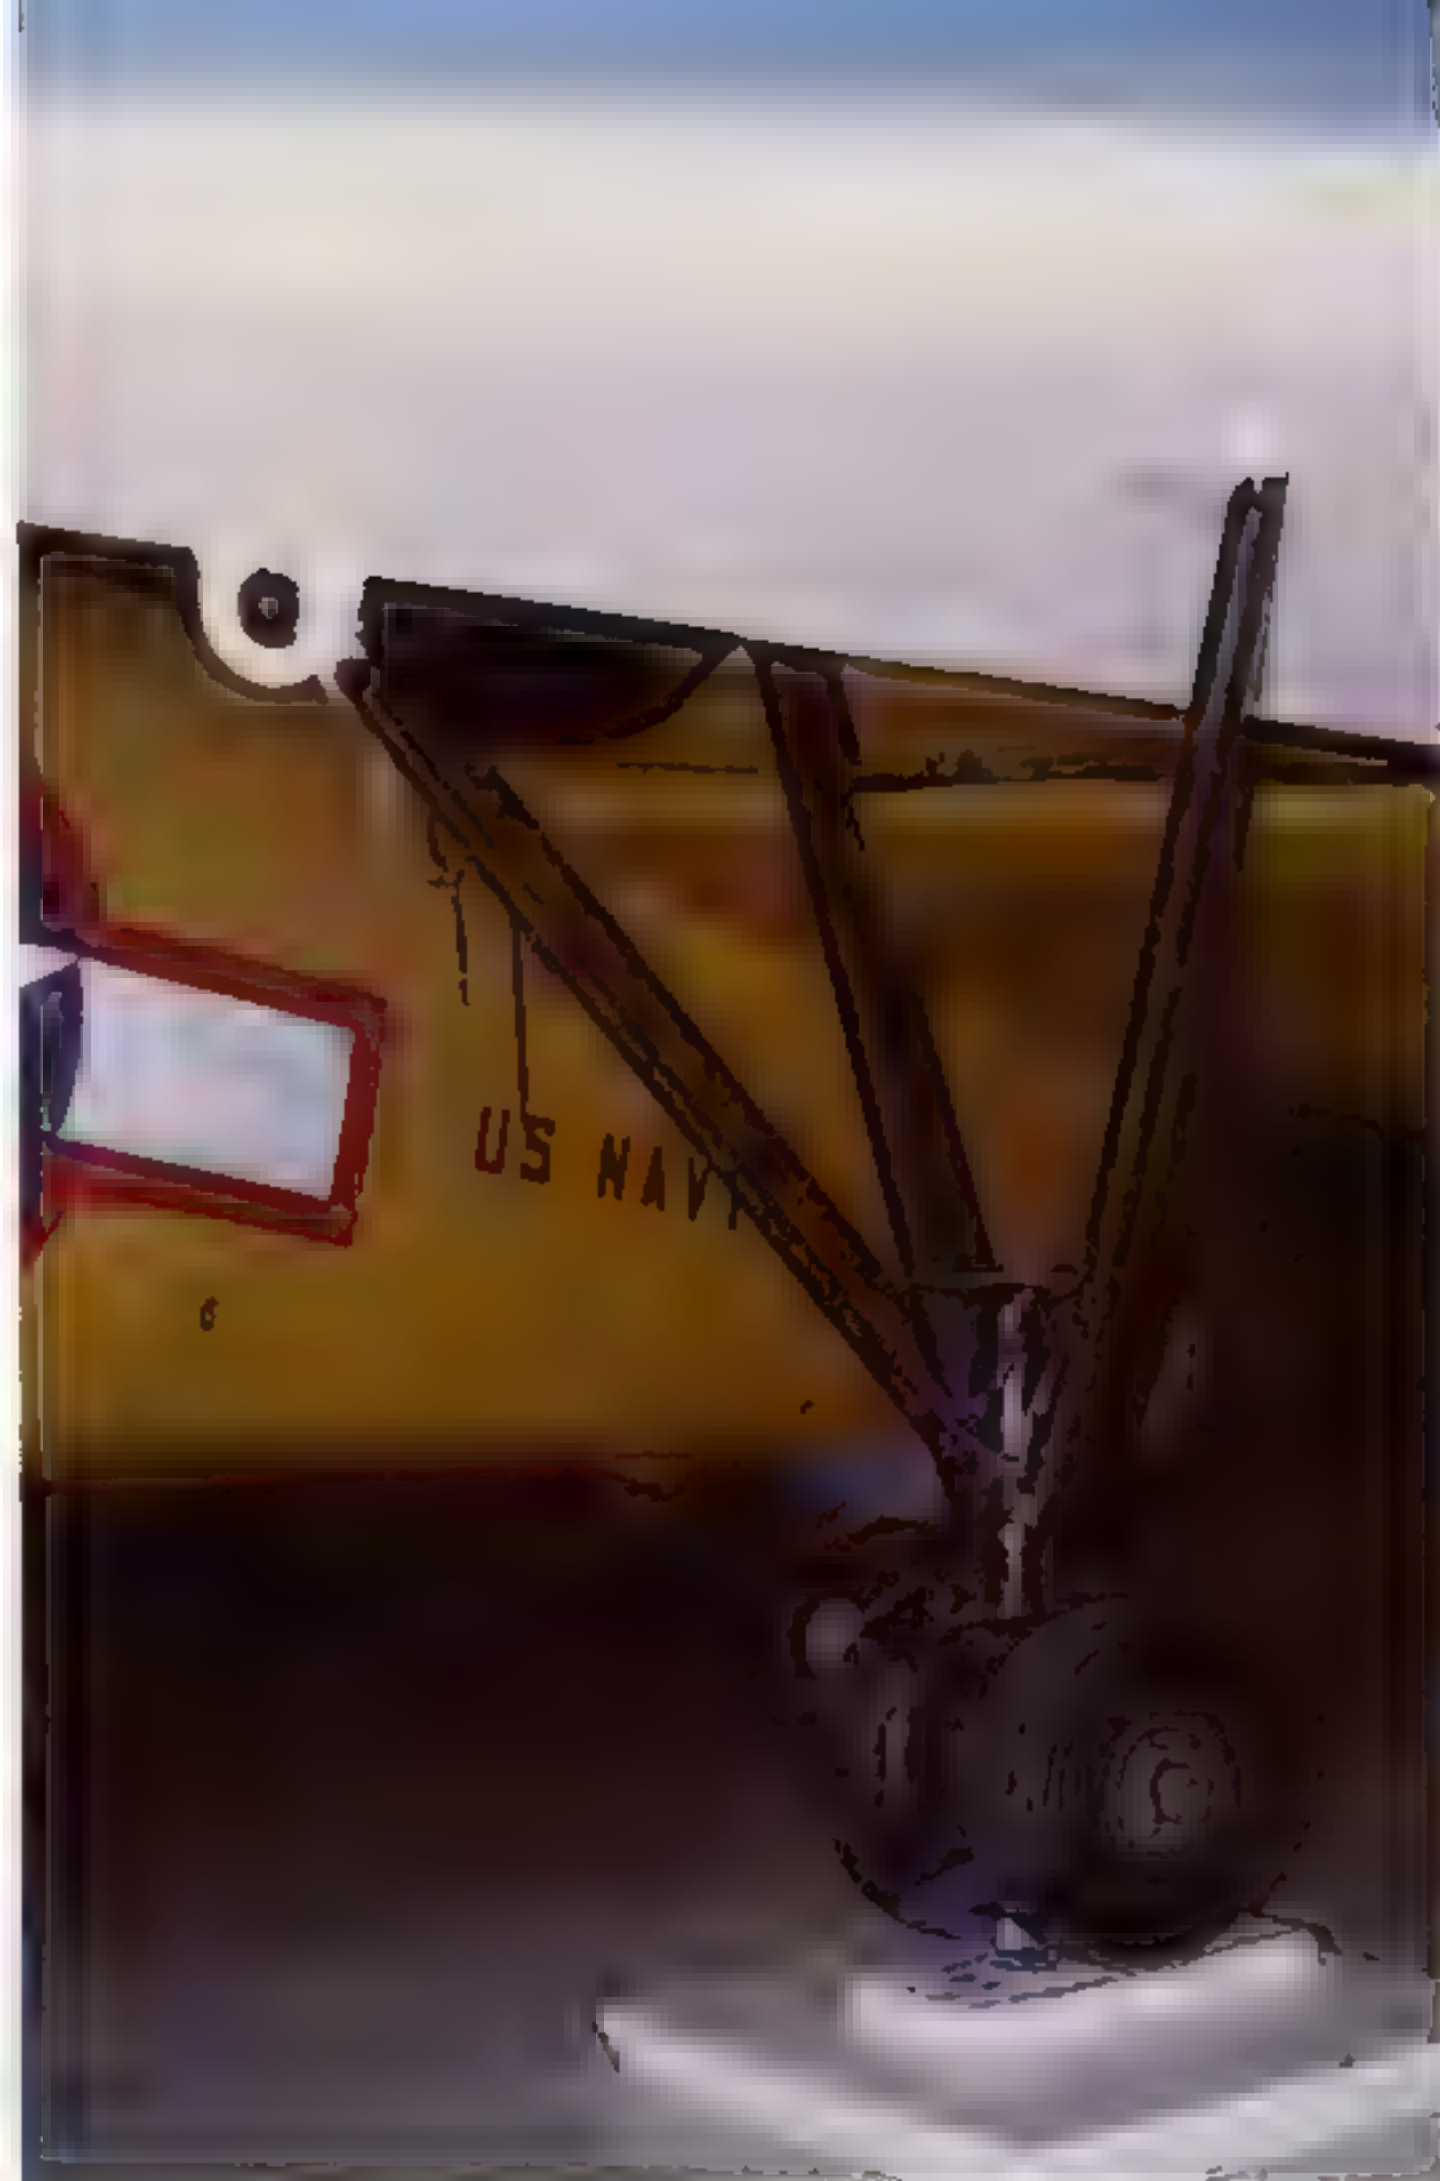
The tail beaching gear mounted on the hull of the PBY-5 at the Naval Aviation Museum at Pensacola, Florida, was up on temporary blocks. (WES)

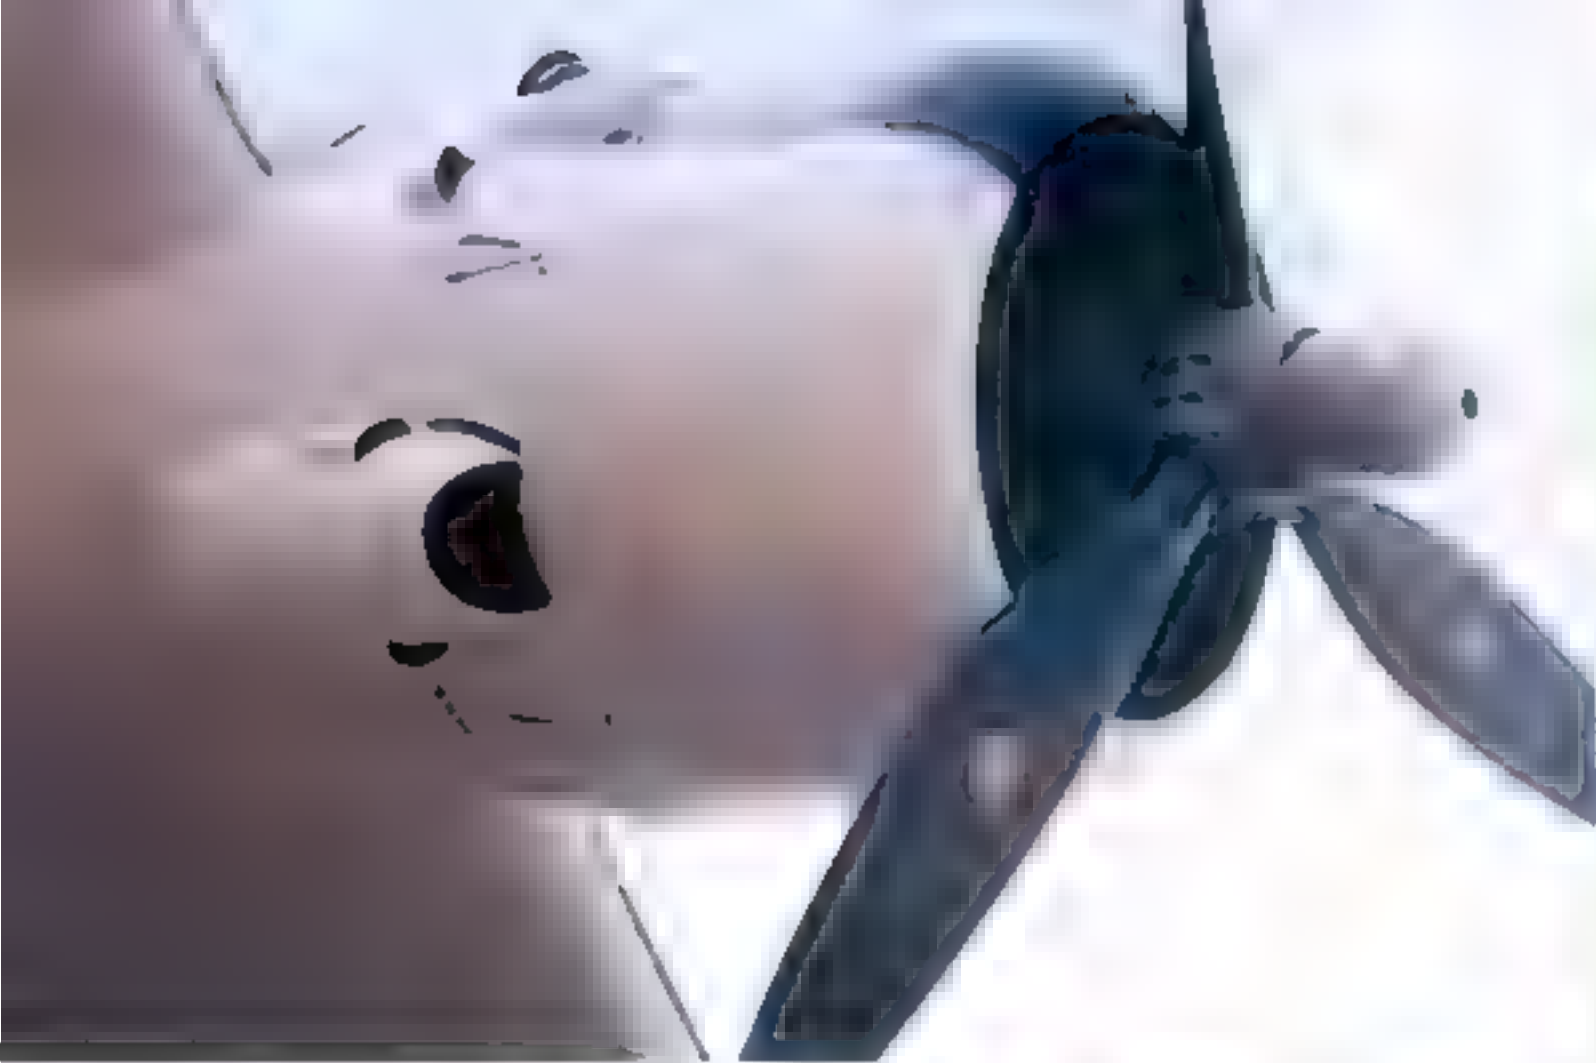
The starboard engine nacelle of a PBV-5A with the cowl flaps closed. The intake on the lower nacelle is the oil cooler housing with coolant vents on each side. The logo on the propeller blades is the company logo for the Hamilton Standard company. (Richard Dann)

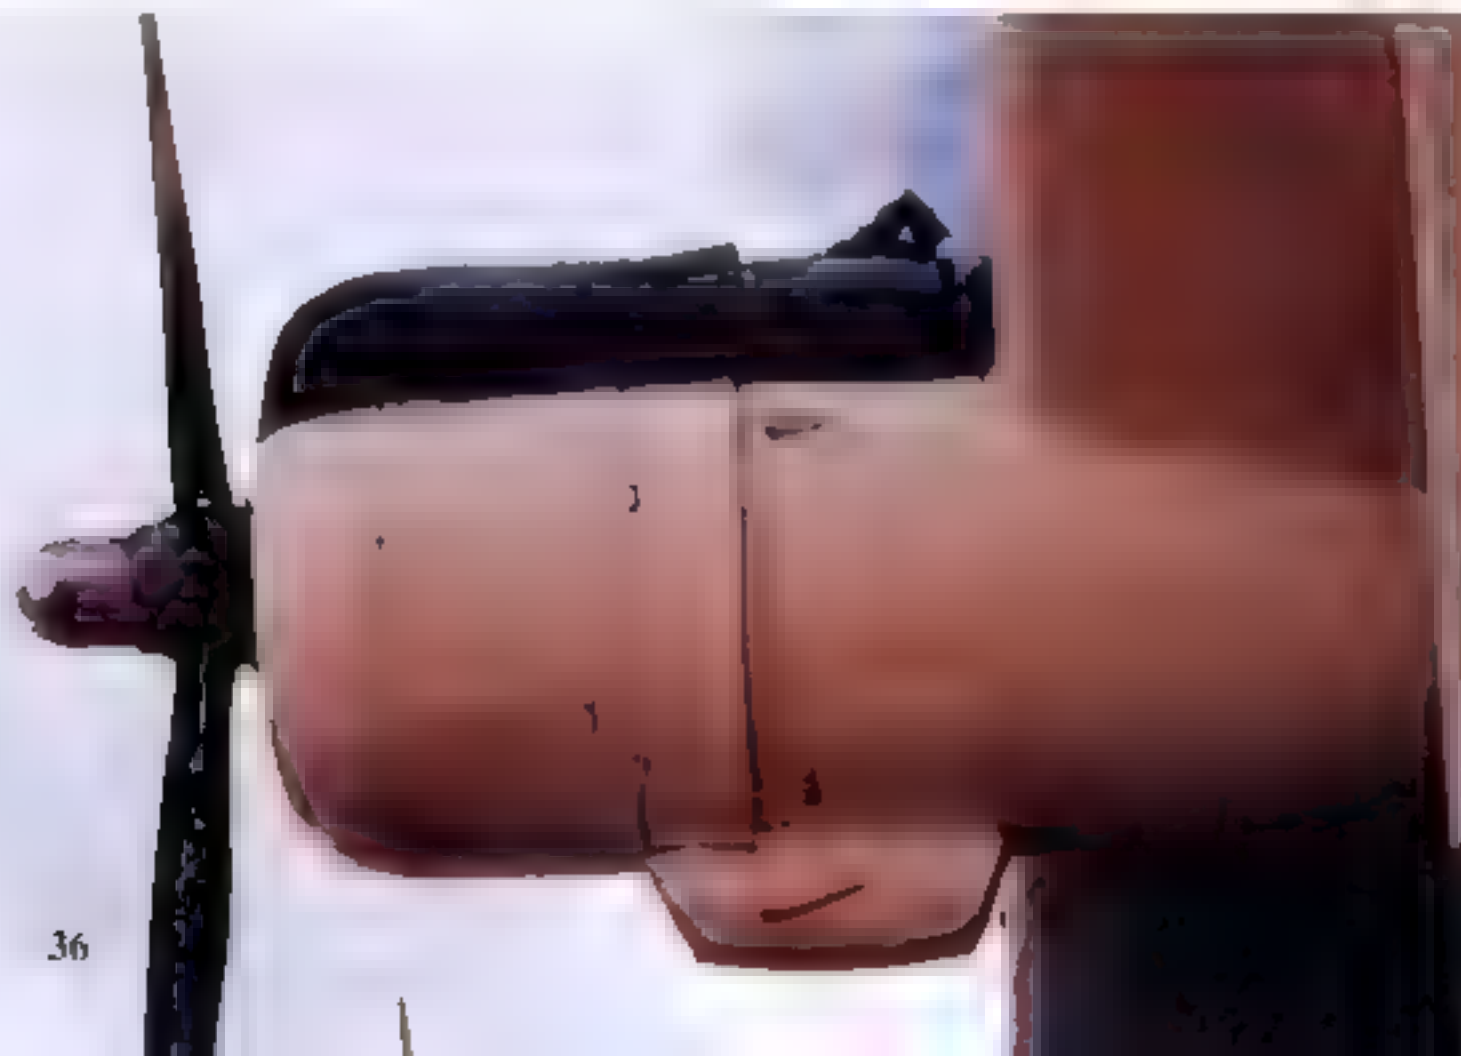
The lower rear starboard engine nacelle of a USAF OA-10A. The oil cooler honeycomb is visible and there are several vents long either side for additional cooling. The cowl flaps are partially open. The small vent in the center is a oil drain valve. (B. Ryle)
